House (Second Street and S.R. 266)  
(McKibben's Grocery)  
Intersection of 2nd Street and S.R. 266  
Stockport  
Morgan County  
Ohio

HABS No. OH-2149

PHOTOGRAPHS  
WRITTEN HISTORICAL AND DESCRIPTIVE DATA

## ARCHITECTURAL DATA FORM

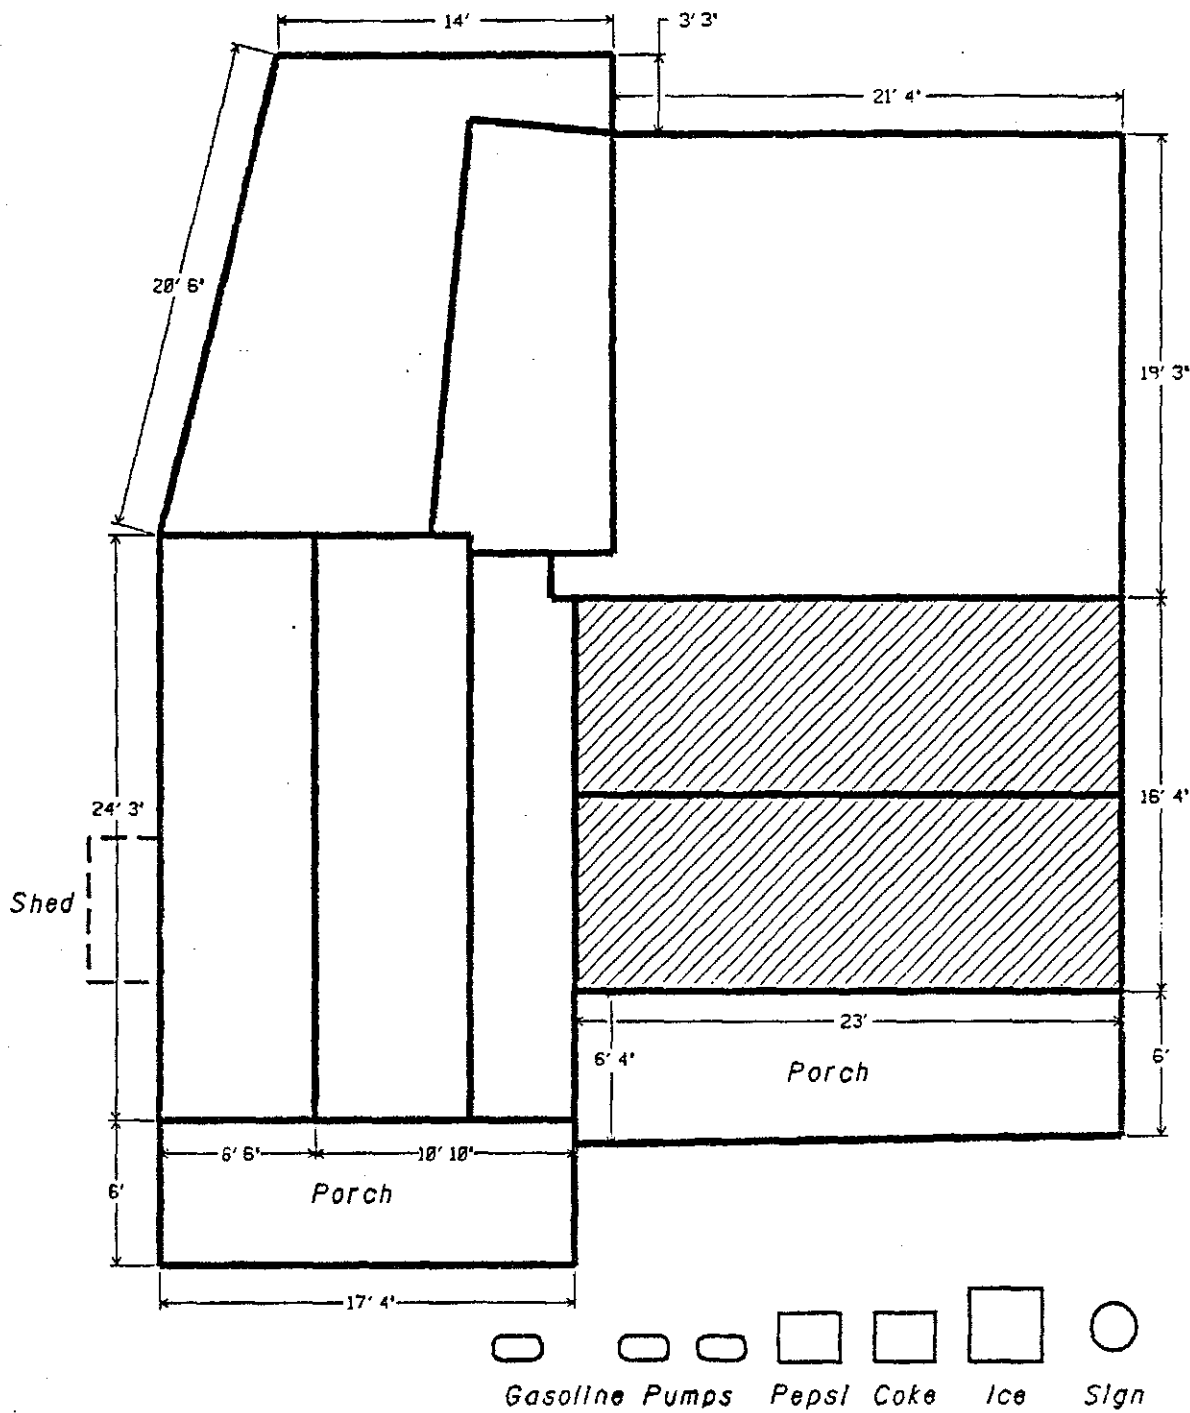
## OVERALL DIMENSIONS

SHAPE AND DIMENSIONS OF STRUCTURE (SKETCHED FLOOR PLANS ON SEPARATE PAGES ARE ACCEPTABLE) Brick residential section: rectangular, 24' x 12'4", plus basement (see sketched floor plans)		
EXTERIOR FEATURES OF NOTE The brick section has been covered with stucco. An asphalt roof covers this section as well as the additions, with the exception of the west side of the grocery store addition which is slate.		
INTERIOR FEATURES OF NOTE (DESCRIBE FLOOR PLANS, IF NOT SKETCHED) See sketched floor plans.		
MAJOR ALTERATIONS AND ADDITIONS WITH DATES Two additions have been added to the south side of the brick section. The kitchen addition connects to another addition which connects to the grocery store additions. According to the current owners, the additions were constructed circa 1930.		
PRESENT CONDITION AND USE The present condition of the entire structure is poor. The brick house and additions immediately to the south are used as the residence. The addition to the east is used as a grocery store and Gulf Oil Company gasoline station.

(crosshatching indicates the original structure)
